STATE OF ILLINOIS  
DEPARTMENT OF TRANSPORTATION

Contract No. 76561

**FLOODWALL REPAIR DETAILS**  
F.A.U. ROUTE 9105 - SECTION 119BR  
MADISON COUNTY  
STRUCTURE NUMBER 060-6002

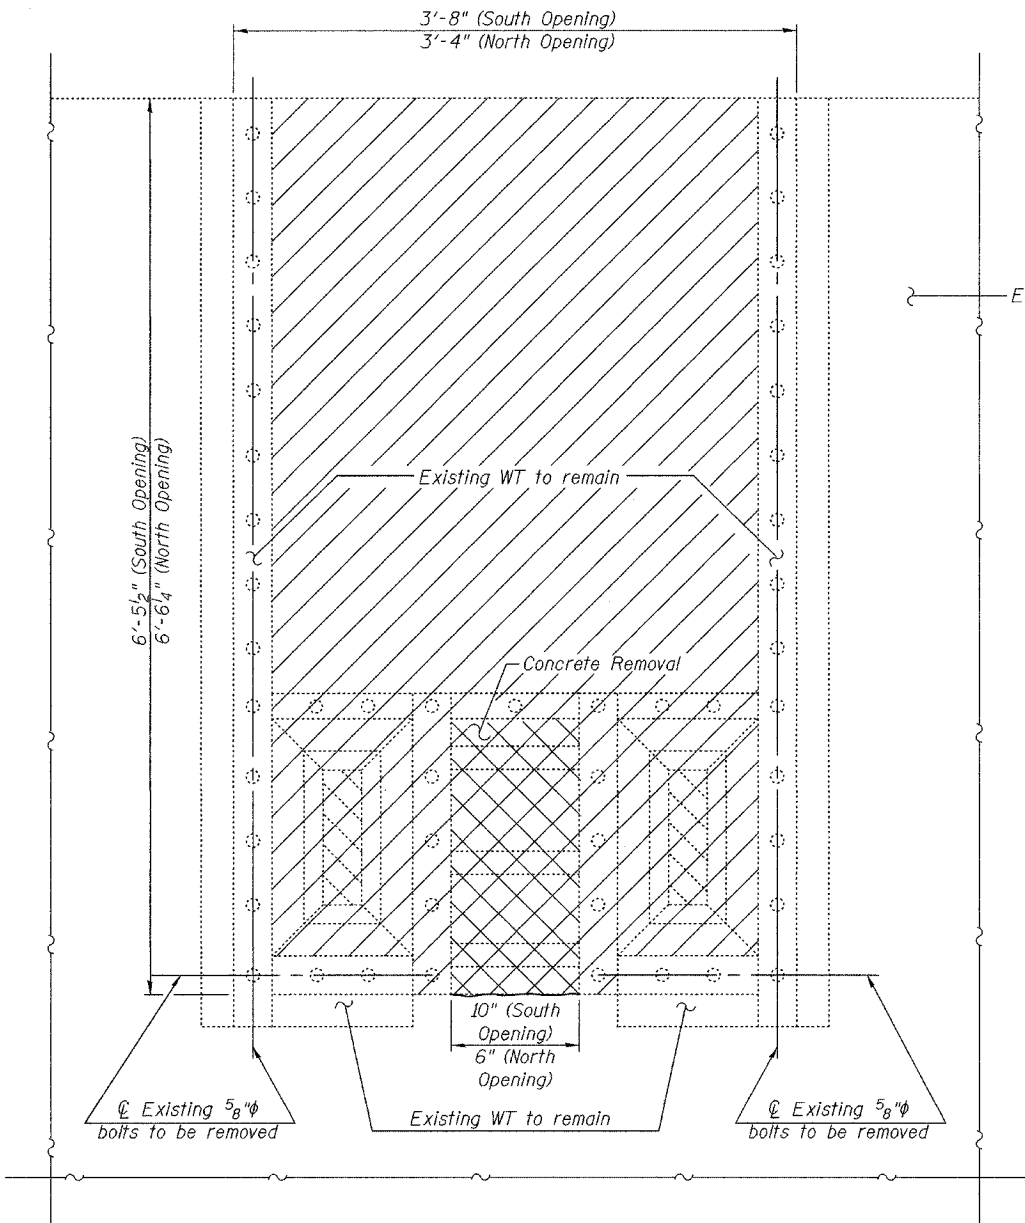
**ELEVATION**

(Showing Existing Condition)

Cross-hatched area shows concrete removal.

This concrete shall be removed by saw cutting.

Hatched areas show removal of existing steel and associated hardware (steel plates, bent plates, seal plates, bolts, rubber seal, etc.). Cost included with Floodwall Repair.

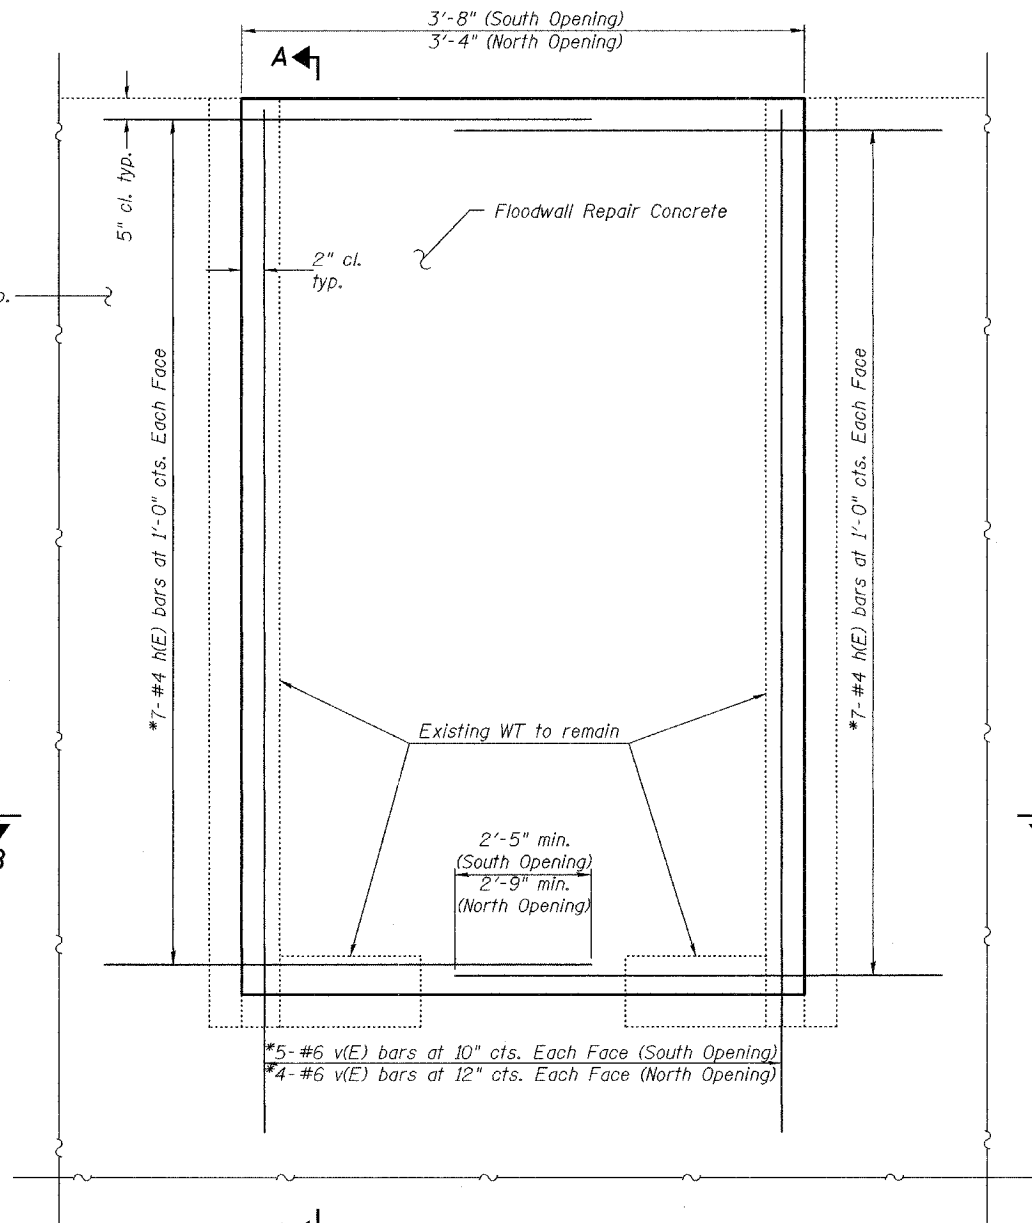
**ELEVATION**

(Showing New Construction)

All materials and the repair method shall conform to the requirements stated in the Corps of Engineers Standard Specifications. See Floodwall Repair Special Provisions.

Any steel to remain shall be cleaned of all rust and oil.
